SERVICE INFORMATION	13-1
TROUBLESHOOTING	13-2
TRANSMISSION DISASSEMBLY	13-3
SHIFT FORK AND SHIFT DRUM	13-5
TRANSMISSION ASSEMBLY	13-8

## TRANSMISSION

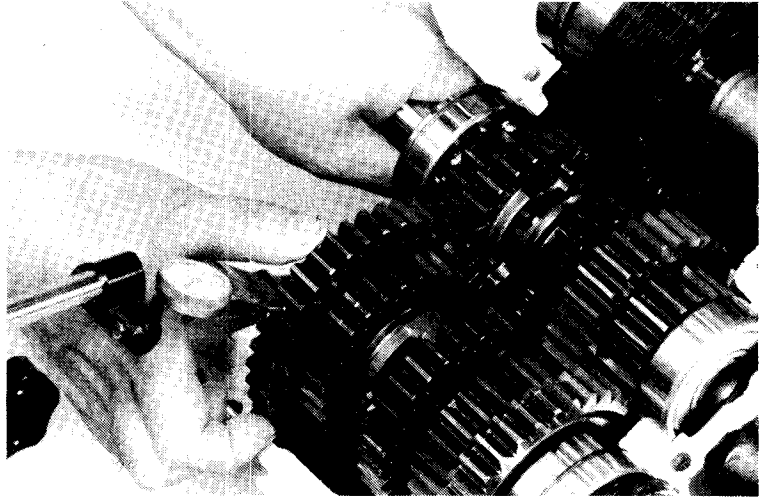
Separate the crankcase (Section 11) and inspect the backlash of each gear.

**SERVICE LIMIT: 0.13 mm (0.0051 in)**

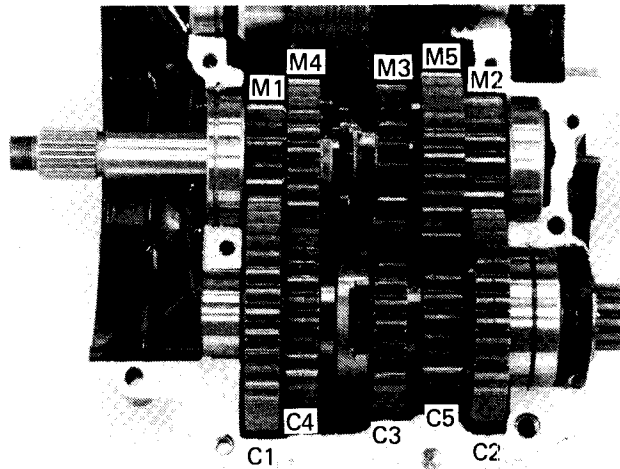
Remove the mainshaft and countershaft.

Remove the dowel pins from the crankcase.

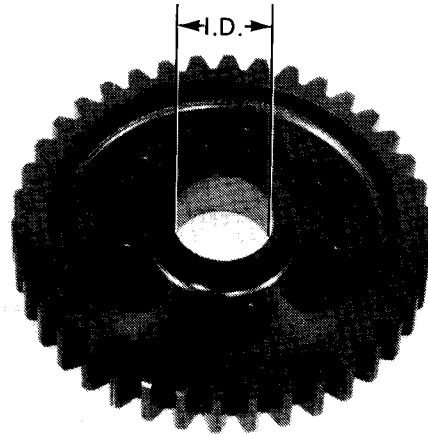
Measure the I.D. of each gear.

**SERVICE LIMITS:**

- M4 gear: 31.07 mm (1.223 in)
- M5 gear: 31.07 mm (1.223 in)
- C1 gear: 25.06 mm (0.987 in)
- C3 gear: 31.07 mm (1.223 in)

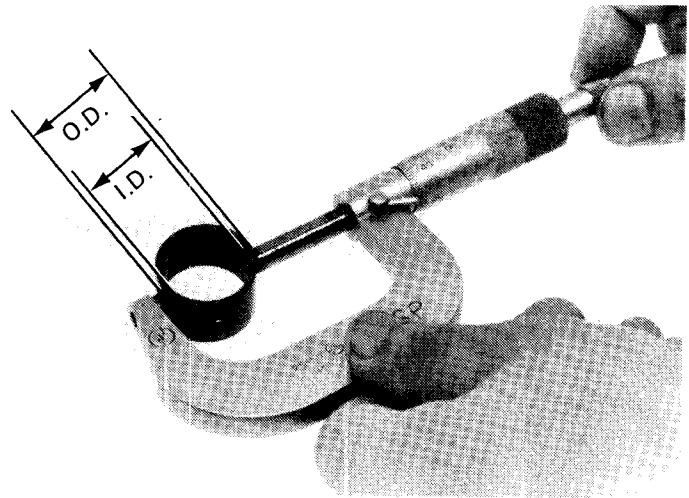
Measure the I.D. and O.D. of the gear bushings.

**SERVICE LIMITS:**

- M4 O.D.: 30.93 mm (1.218 in)
- M5 O.D.: 30.93 mm (1.218 in)
- C1 O.D.: 24.93 mm (0.981 in)
- C1 I.D.: 22.04 mm (0.868 in)
- C3 O.D.: 30.93 mm (1.218 in)

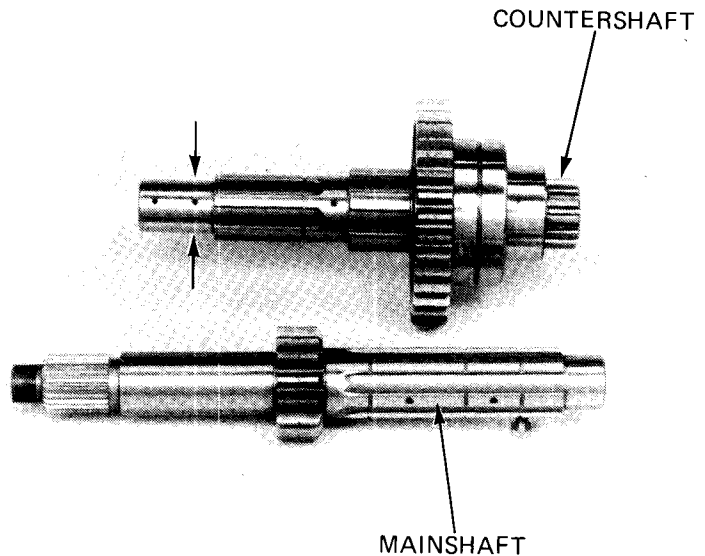
Measure the O.D. of the countershaft at the C1 bushing.

**SERVICE LIMITS: 21.930 mm (0.8634 in)**

Calculate the clearance between the gears and shaft or bushings.

- M5 to M5 bushing: 0.12 mm (0.005 in)
- M4 to M4 bushing: 0.12 mm (0.005 in)
- C1 to C1 bushing: 0.08 mm (0.003 in)
- C1 bushing to shaft: 0.045 mm (0.002 in)
- C3 to C3 bushing: 0.12 mm (0.005 in)

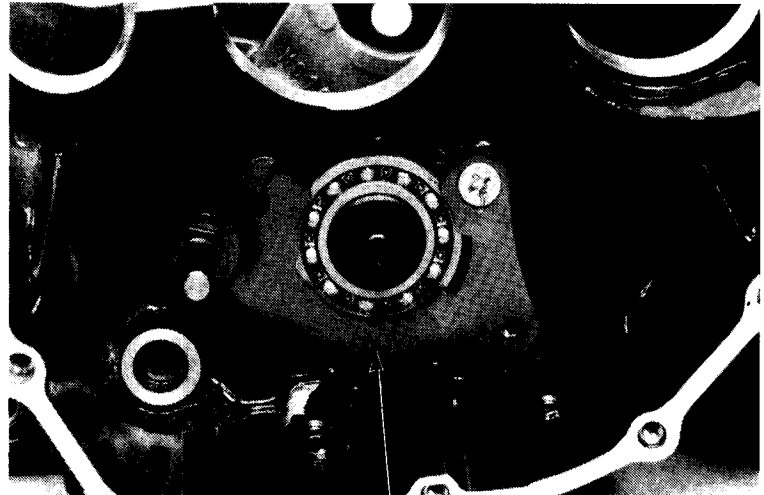
BEARING STOPPER PLATE

Remove the bearing stopper plate.

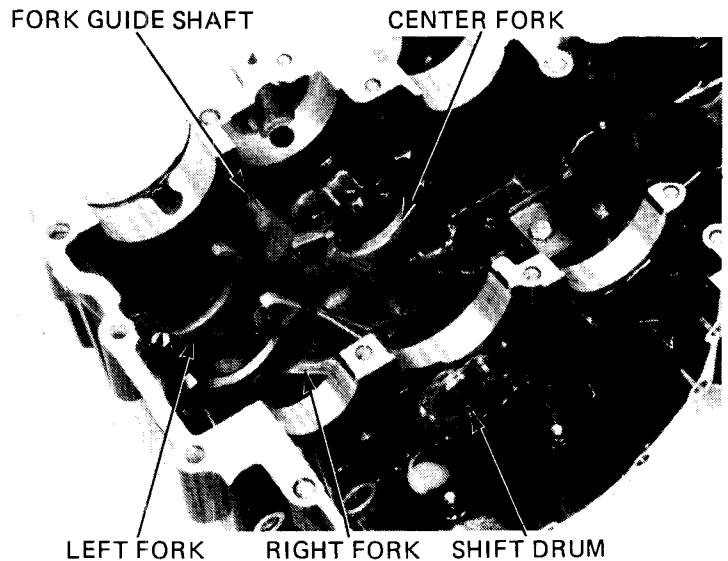
Remove the shift fork shaft and shift forks.  
Remove the shift drum.

FORK GUIDE SHAFT

CENTER FORK

LEFT FORK

RIGHT FORK

SHIFT DRUM

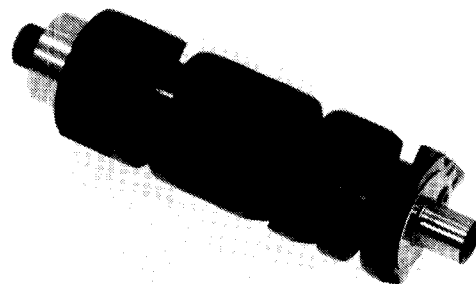
Inspect the shift drum end for scoring, scratches, or evidence of insufficient lubrication.

Check the shift drum grooves for damage.

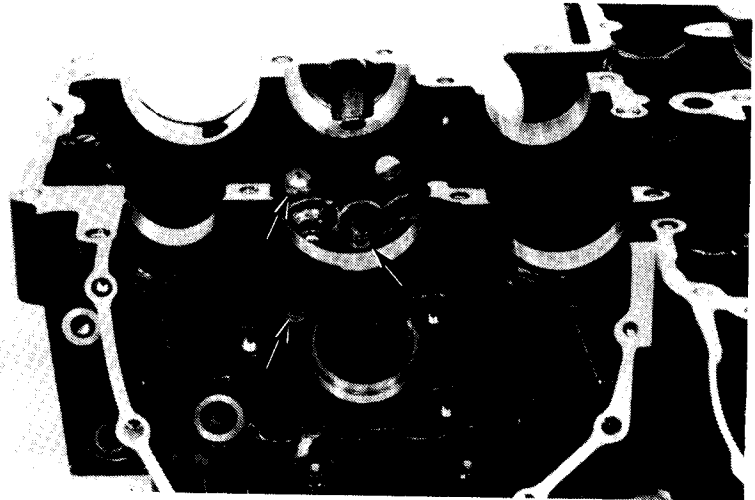
Inspect the shift drum hole and shift fork shaft holes for scoring or scratches.

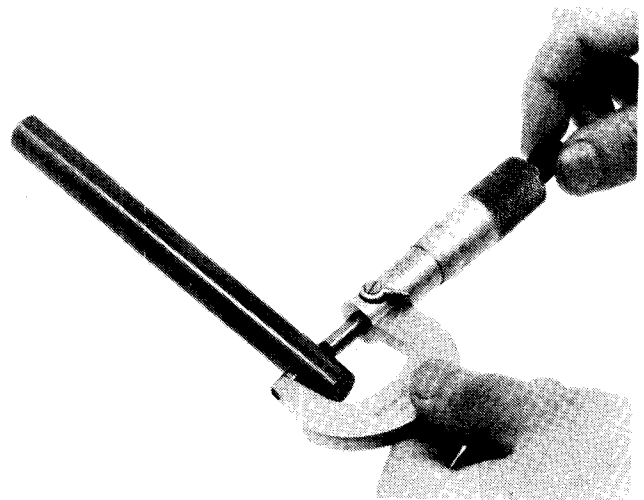
Measure the shift fork shaft O.D.

**SERVICE LIMIT: 12.90 mm (0.508 in)**

Check for scratches, scoring, or evidence of insufficient lubrication.

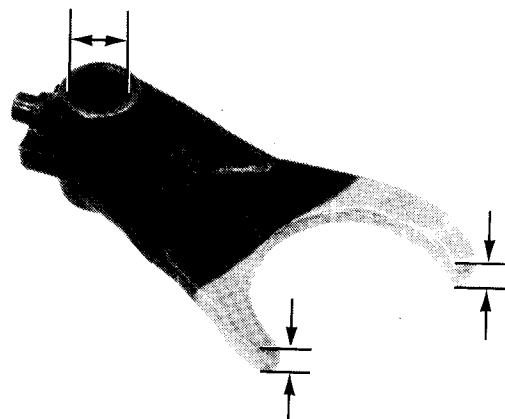
Measure the shift fork I.D. and claw thickness.

**SERVICE LIMITS:**

**I.D.:** 13.04 mm (0.513 in)

**CLAW THICKNESS:** 6.1 mm (0.24 in)

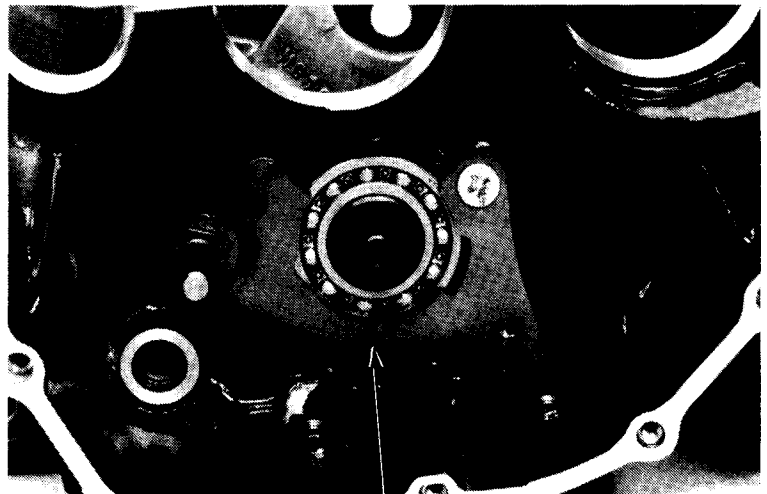
**BEARING STOPPER PLATE**

**CAUTION:**

*When installing the bearing stopper plate, apply a locking agent to the screw threads.*

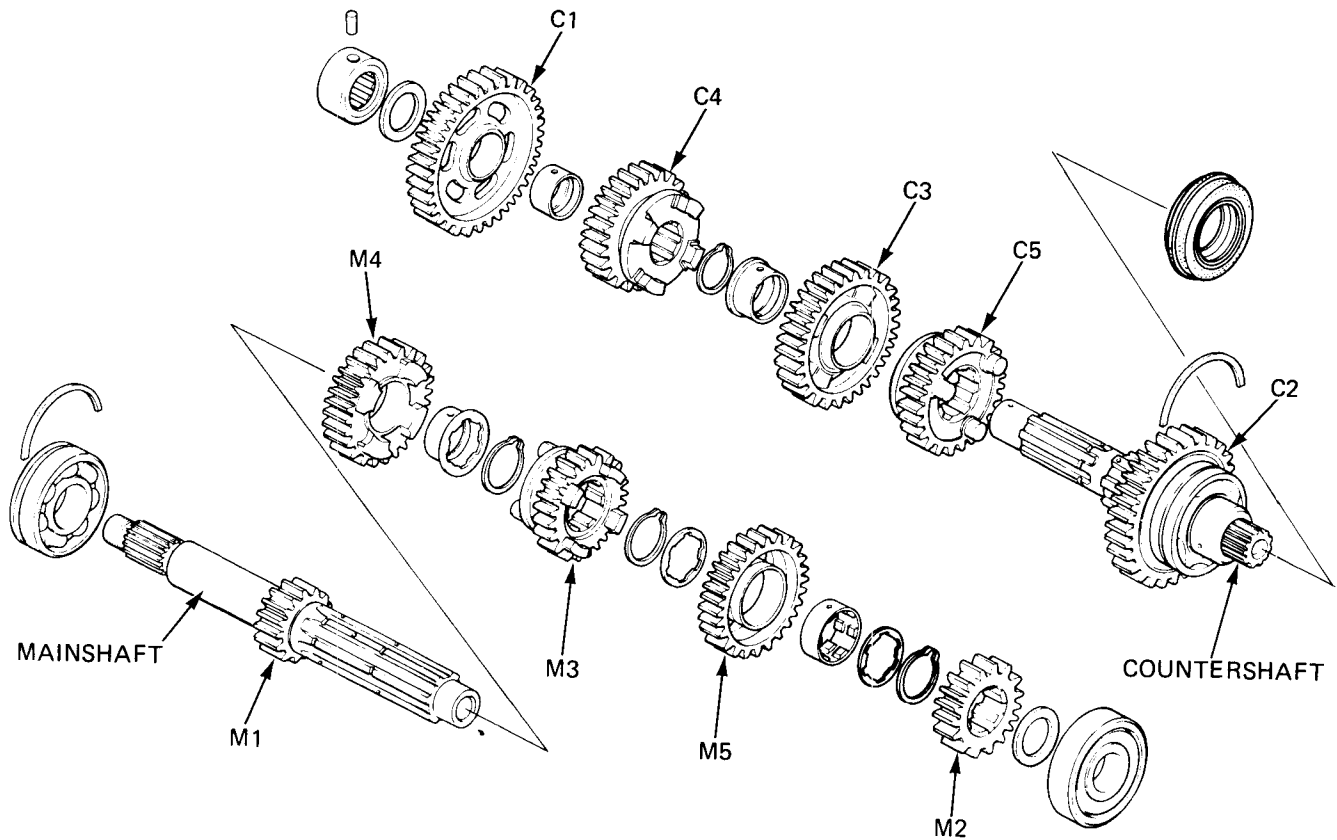
Assemble the mainshaft and countershaft.

**NOTE:**

- Check the gears for freedom of movement or rotation on the shaft.
- Check that the snap rings are seated in the grooves.

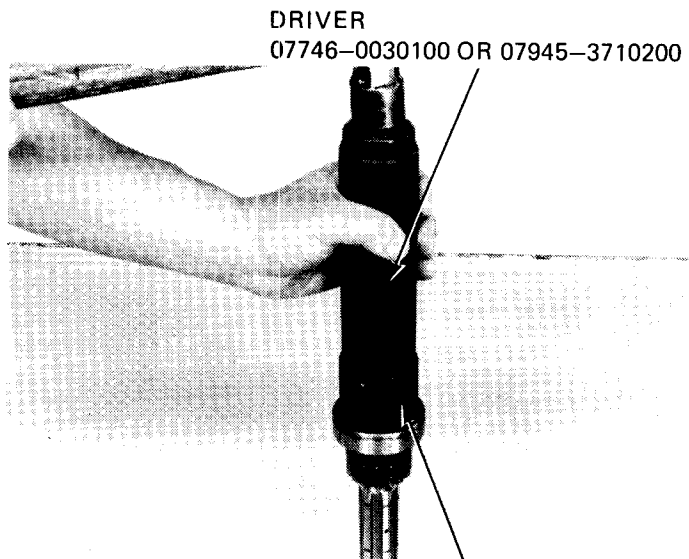
Install the mainshaft bearing with the tools.

**DRIVER**  
07746-0030100 OR 07945-3710200

Attachment, 25 mm I.D.  
07746-0030200 OR 07945-3710200

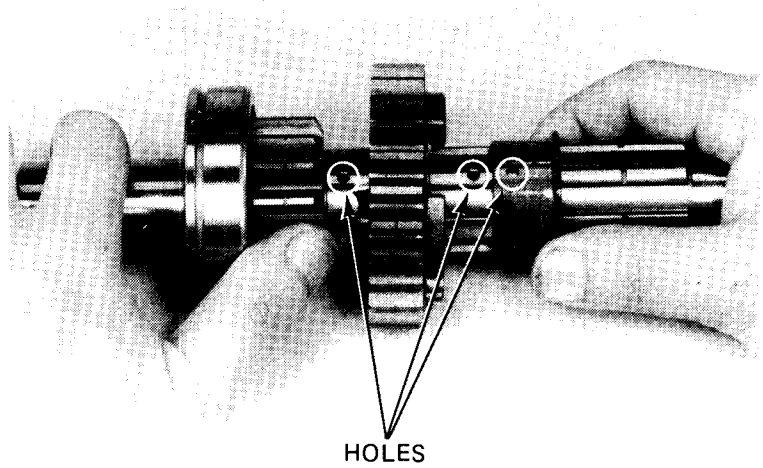
Align the holes in the M4 and M5 gear bushings with the hole in the mainshaft.

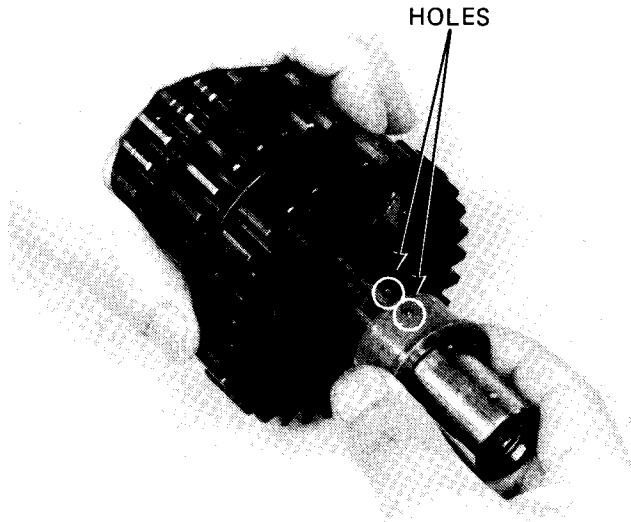
Align the hole in the C3 gear bushing with the hole in the countershaft.

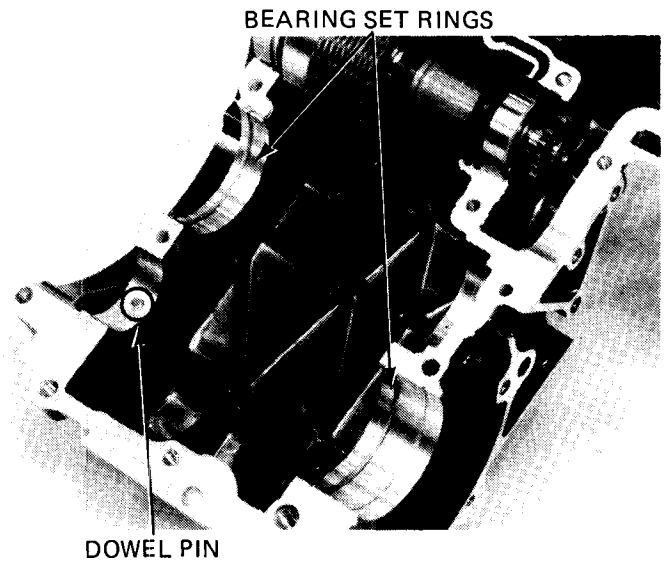
Insert the dowel pin and bearing set rings.

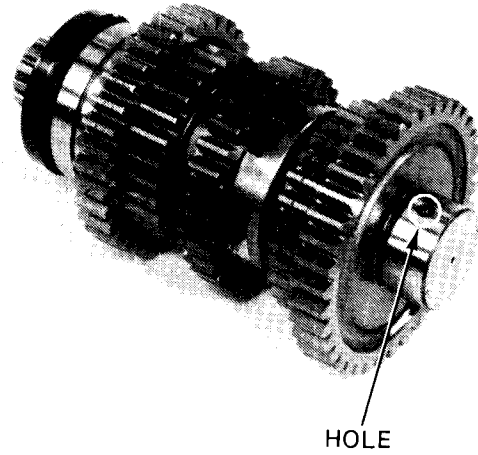
Align the hole in the countershaft bearing with the dowel pin.

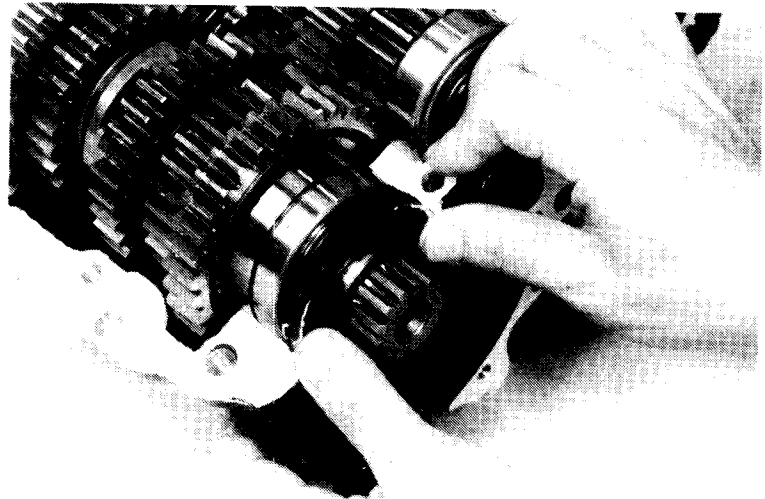
**NOTE:**

Push the countershaft oil seal in until the oil seal lip is seated completely on the bearing before assembling the lower crankcase to prevent oil leakage.

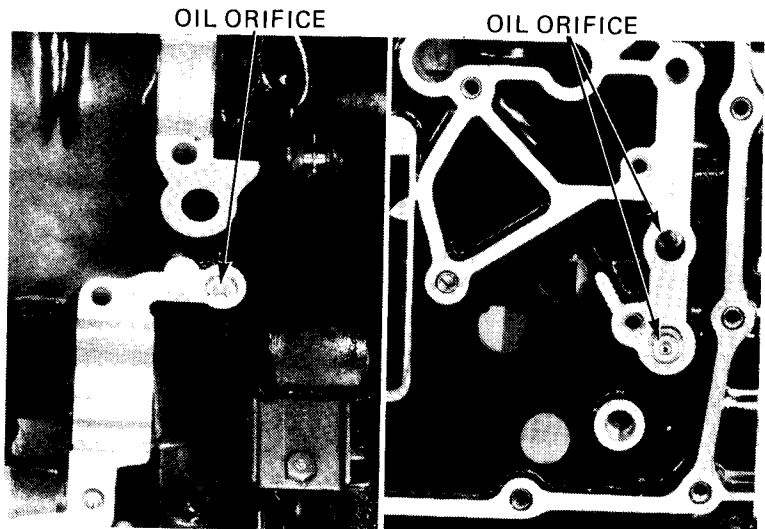
Install the lower crankcase (Refer to Section 11).

**NOTE:**

Check the oil orifice for clogging, before installing the lower crankcase.
